PROPERTY INSPECTION REPORT

Marvin S Whyte
Eastern Idaho Home Inspections, LLC

1234 Any Street
Inspection Prepared For: INSPECTION SAMPLE
Agent:

Date of Inspection: 12/13/2024
Age of House: 46 Size:
Weather:

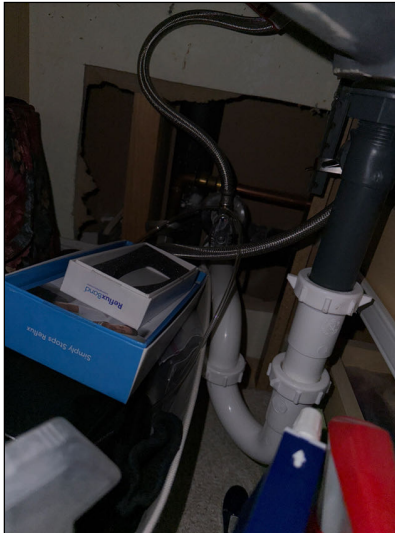
- Limited review due to personal property stored in undersink cabinet.

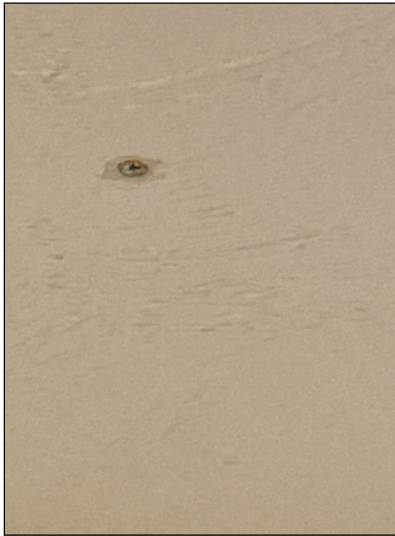
3. Ceiling Condition

There is one screw popping out of the ceiling.

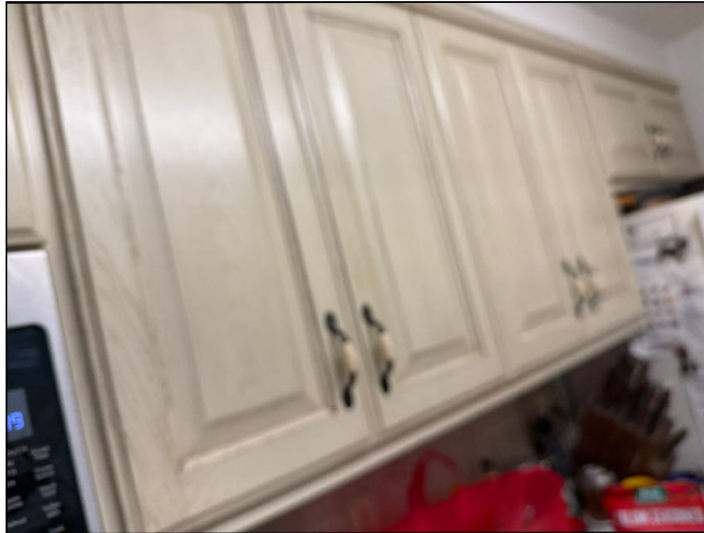
- No deficiencies observed on all kitchen cabinets.
- Appeared functional and in satisfactory condition, at time of inspection.

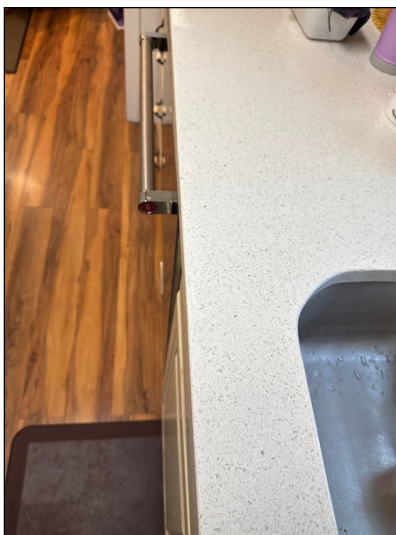
2. Counters

- Solid Surface tops noted.

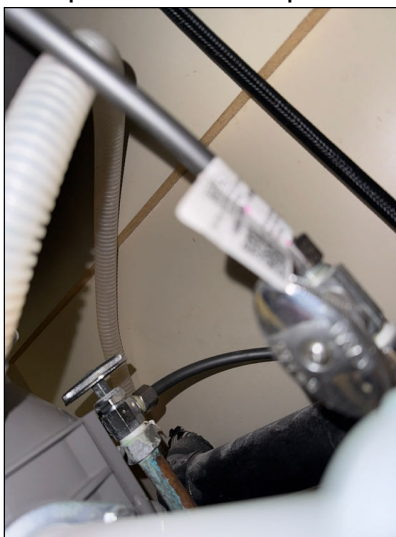
3. Dishwasher

- Dishwasher was operational at the time of inspection. Dishwashers most commonly fail internally at the pump, motor or seals. We do not disassemble these units to inspect these components. We recommend you operate this unit prior to closing.

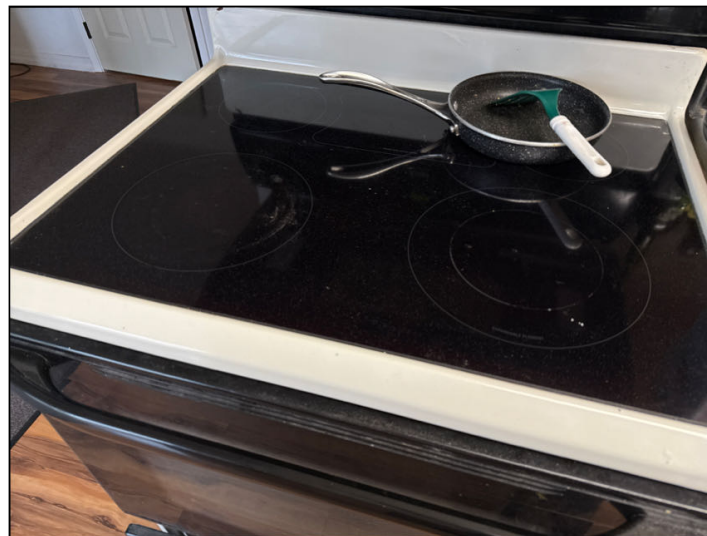
6. Cook top condition

- Electric cook top noted.

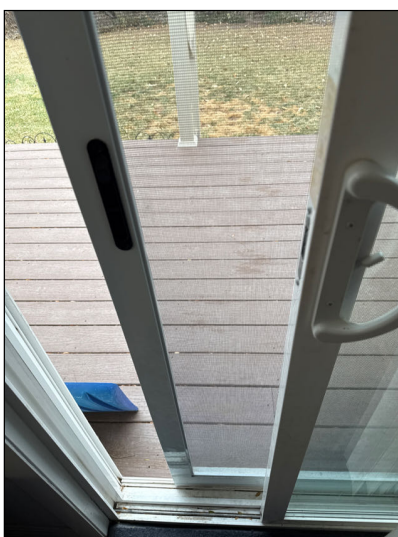
13. Screen Doors

- Sliding door screen is functional.

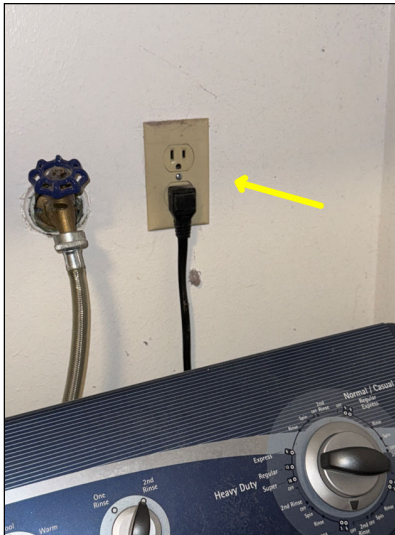
4. Electrical

- The receptacles near laundry machines are polarized and should be GFCI.
- The majority of grounded receptacles , were tested and found to be wired correctly.

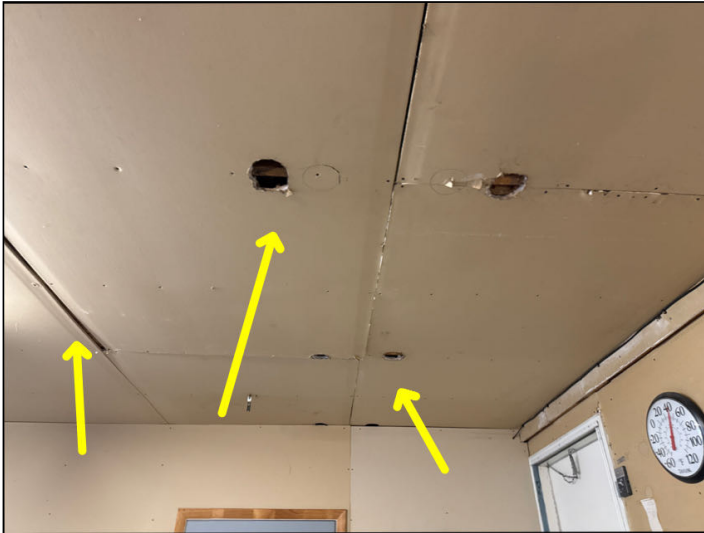
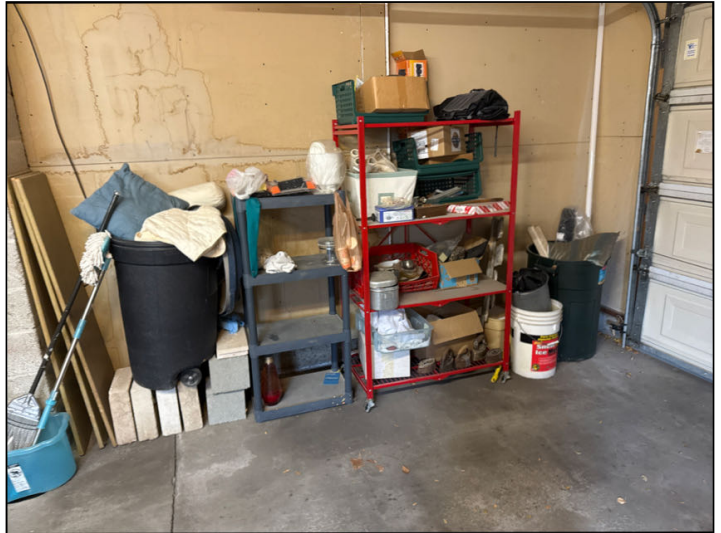
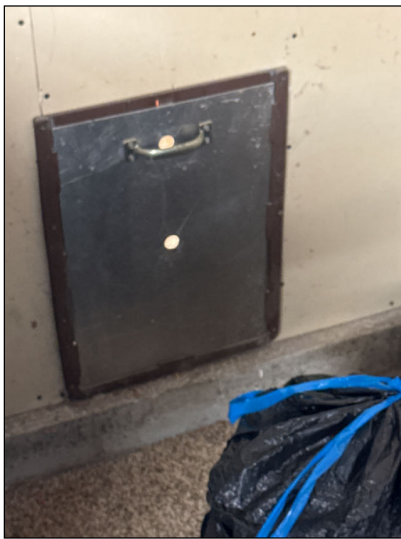
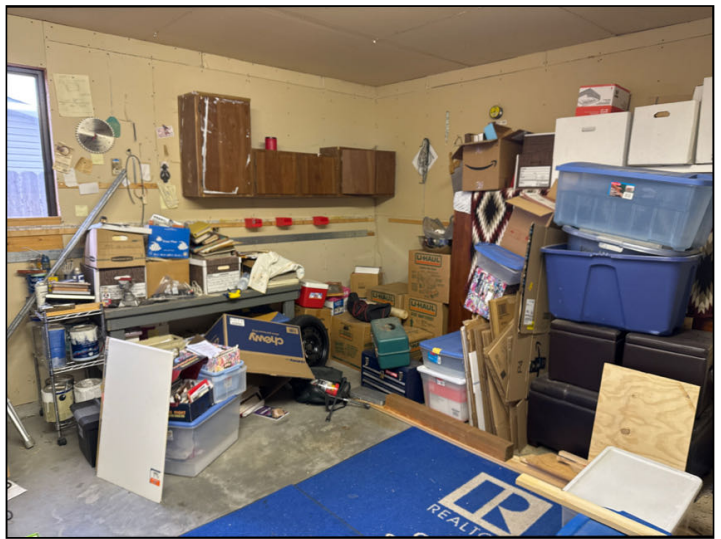
1. Walls

- Garage drywall ceiling needs to be properly repaired.
- No major system safety or function concerns noted at time of inspection.
- Pet Door Installed; this may compromise security or firewalls.
- Personal items prevent complete inspection.

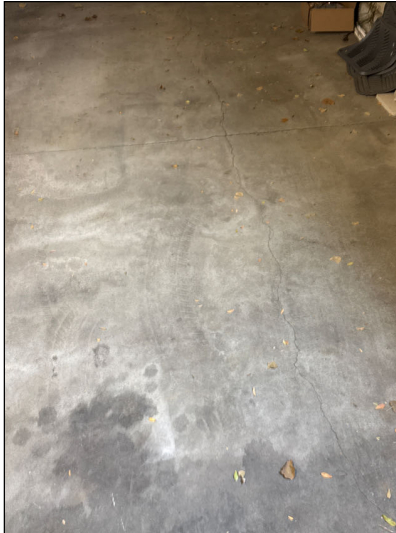
3. Floor Condition

- Common cracks noted.

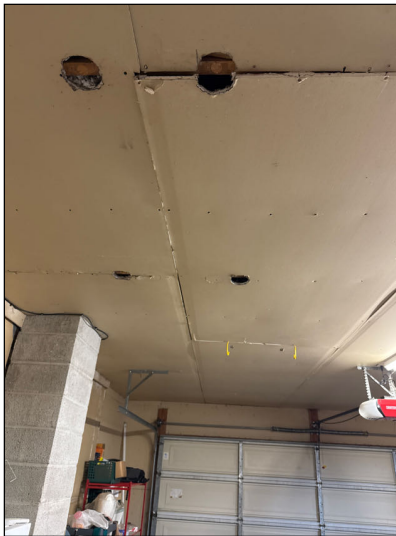
4. Rafters & Ceiling

- Garage drywall ceiling needs to be properly repaired.
- Hole in the ceiling is a breach in the fire protection.
- Limited review due to finished ceilings.

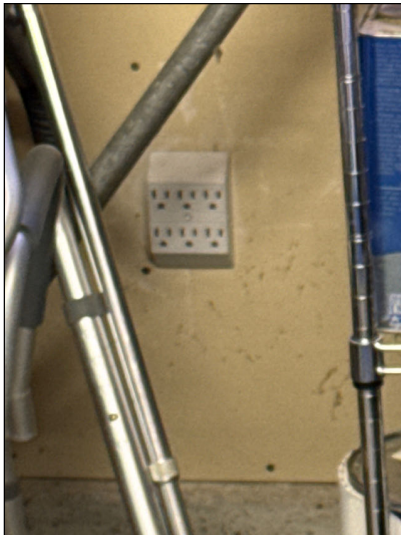
5. Electrical

- Some outlets not accessible due to furniture and or stored personal items.
- It is recommended to avoid use of multiplier outlet plug ins (converts 2 into 6 outlets)

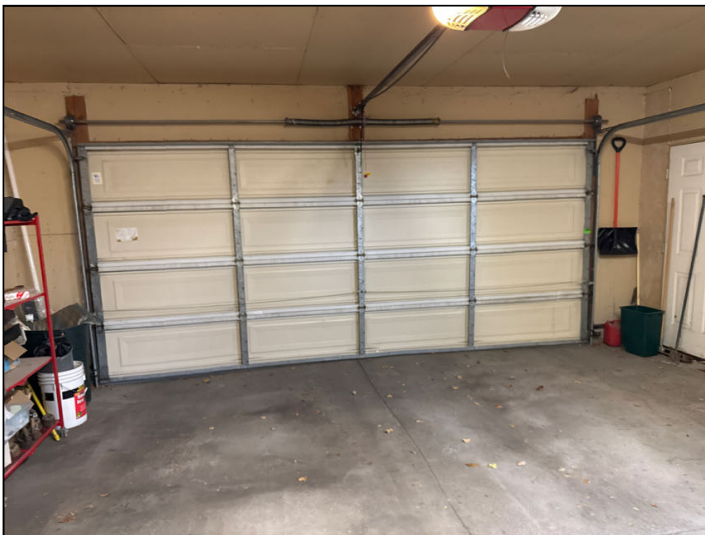
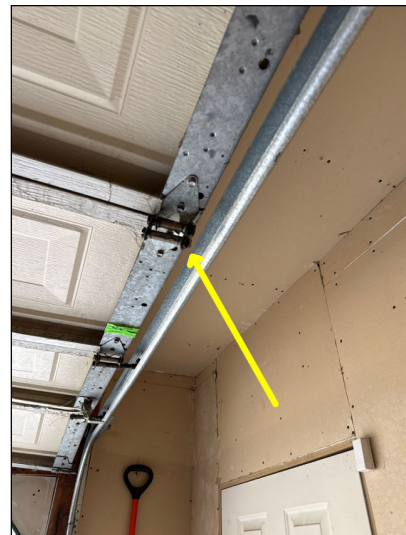
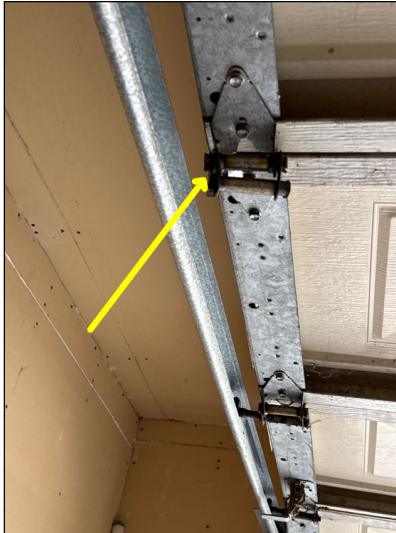
6. Garage Door Condition

Page 30 Item: 6	Garage Door Condition	• Maintenance repairs needed. • Missing rollers on the door.

- missing hardware
- Maintenance repairs needed.
- Missing rollers on the door.

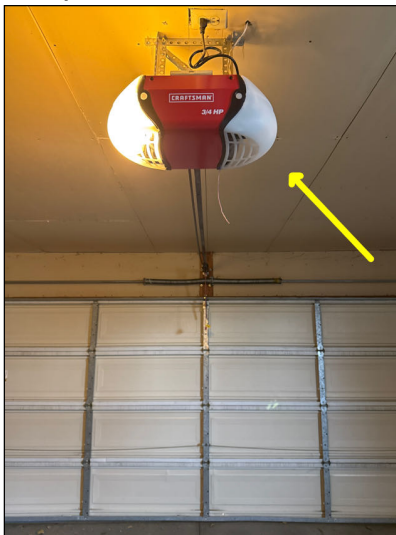
7. Garage Opener Status

- Chain drive opener noted.
- The garage door opener is functional, safety features are built in.
- Appeared functional using normal controls, at time of inspection.
- Right hand GDO light missing. Repair as needed.

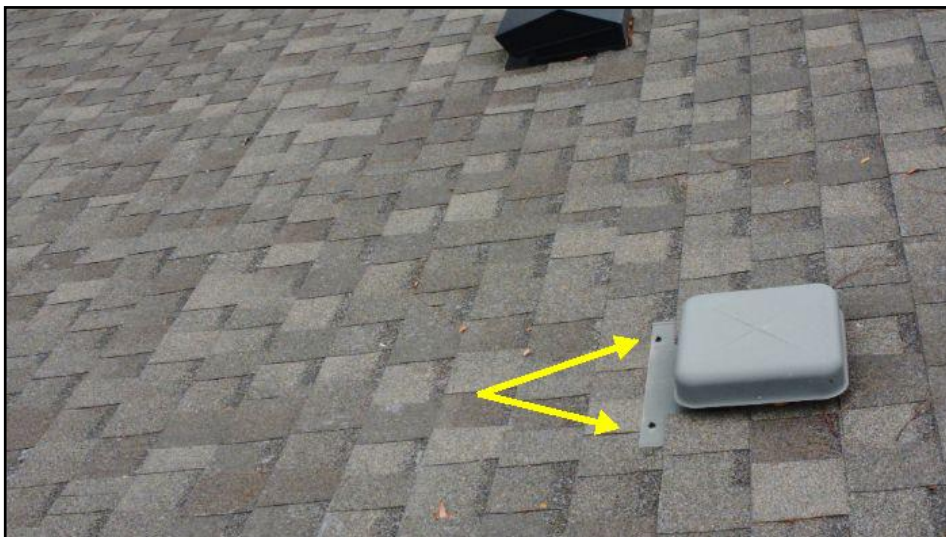
4. Vent Caps

Two nails exposed.

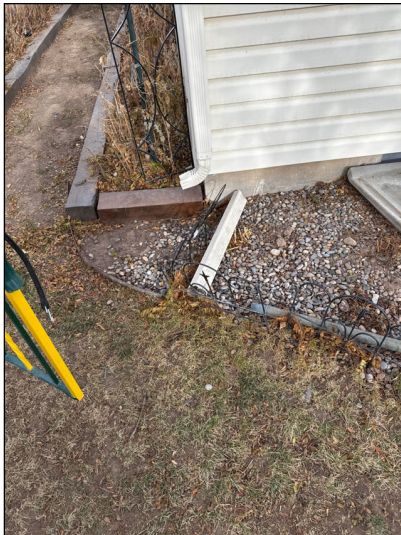
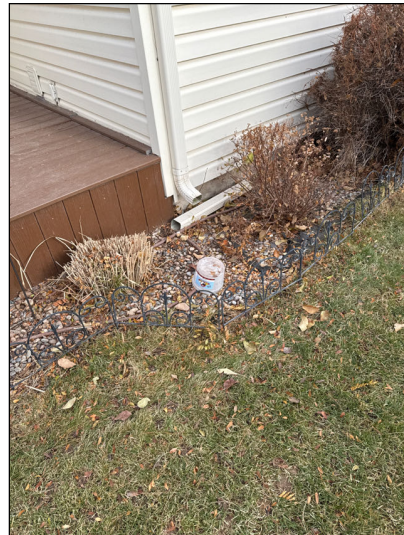
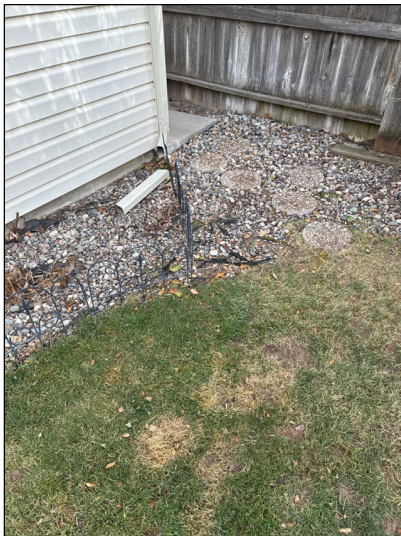
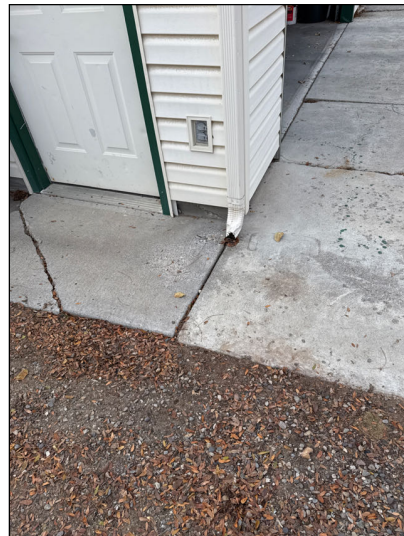
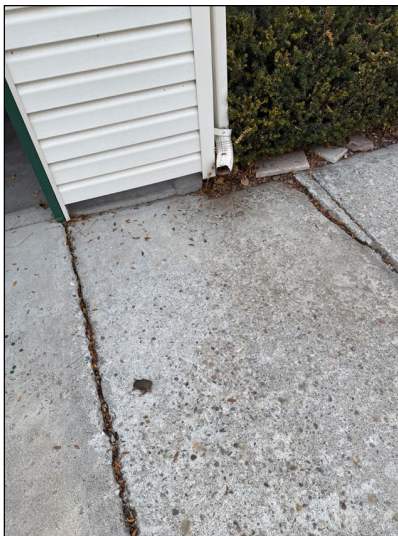
5. Gutter

- Extensions / Splash blocks missing or insufficient: Install to divert water away from the foundation.
- Downspout drains onto sidewalk / driveway. Recommend exploring ways to divert water away from this area, or at the very least, recognize this as a potential ice hazard; use ice melt products and exercise caution.
- Partial gutters - Full installation recommended to keep water away from structure. Water can weaken the foundation and deteriorate the siding. Be sure to install splashblocks or extensions to carry water away, and keep water from areas such as driveways or walks where it can be an ice hazard in winter.
- Make sure all downspouts are connected and routed to discharge away from the homes foundation, this will reduce the potential for water to seep into the basement.

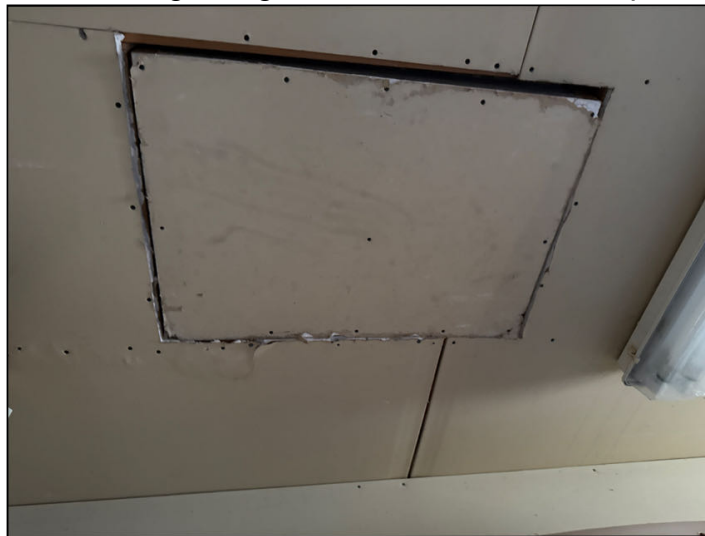
- Garage ceiling.

- Did not inspect, unable to access attic due to hatch inaccessibility. Recommend review of the Sellers Disclosure Statement regarding the condition of the attic prior to close.

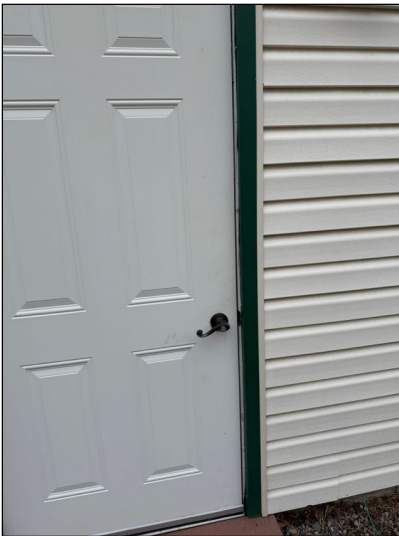
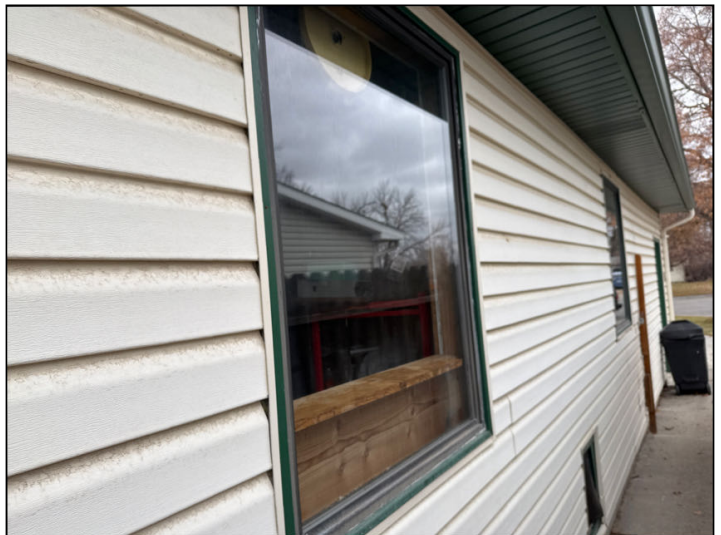
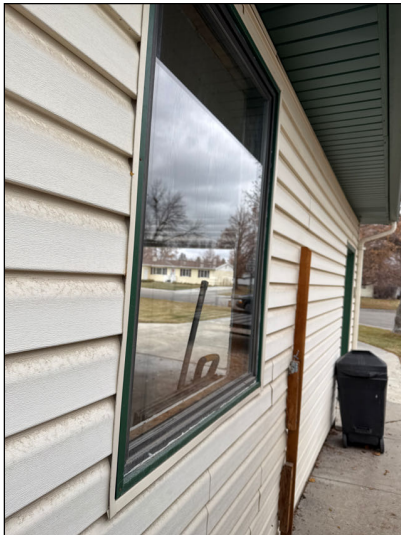
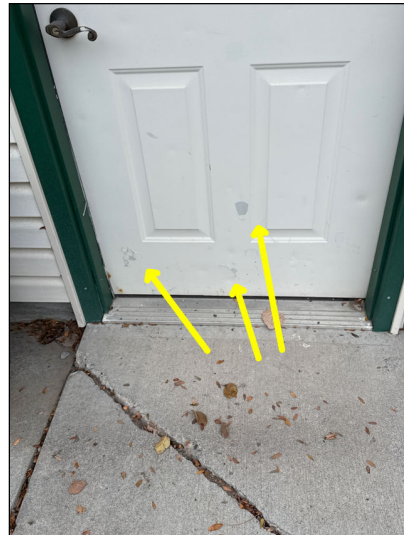
- Appeared in functional and in satisfactory condition, at time of inspection.
- Peeling paint observed, suggest scraping and painting as necessary.
- Exterior of back door is getting weathered, may need a new coat of paint.

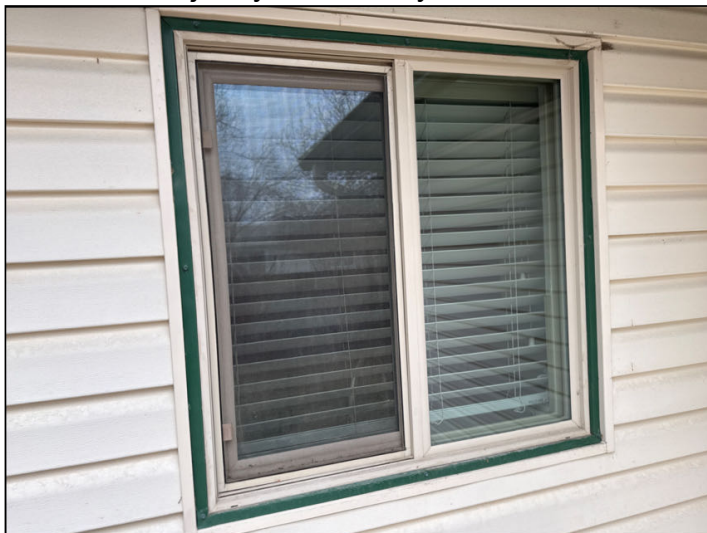
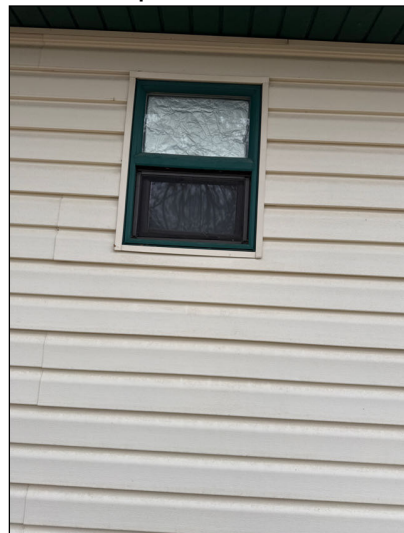
2. Window Condition

- Components appeared in satisfactory condition at time of inspection.
- No major system safety or function concerns noted at time of inspection.

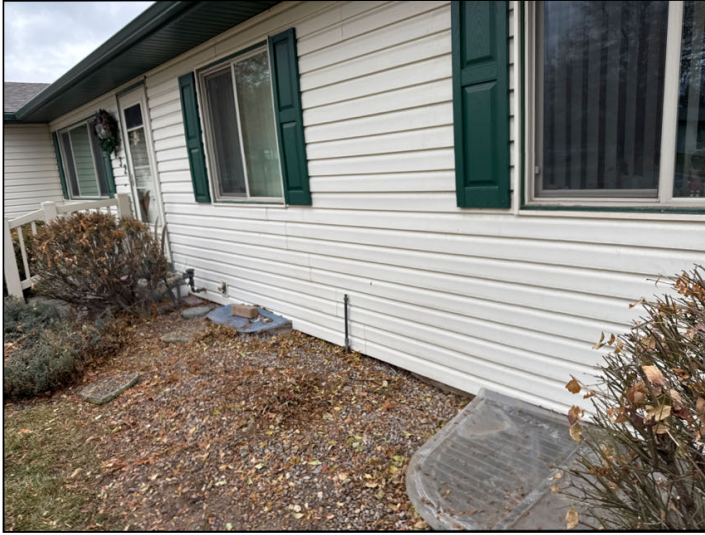
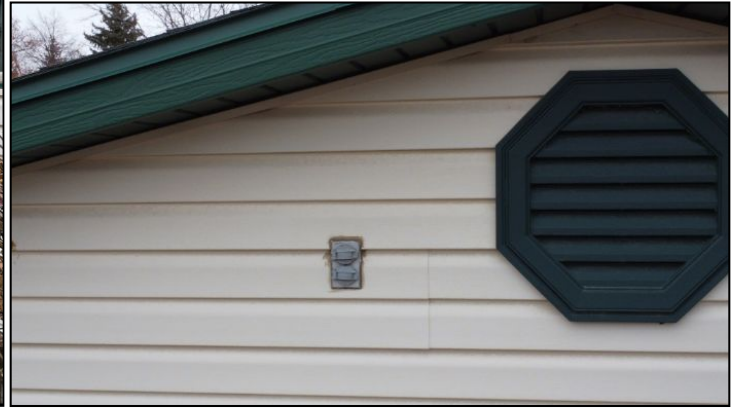
3. Siding Condition

Materials: Vinyl siding, wood frame construction, concrete / block foundation • Vinyl siding noted.

- No major system safety or function concerns noted at time of inspection.
- No major system or safety concerns noted.

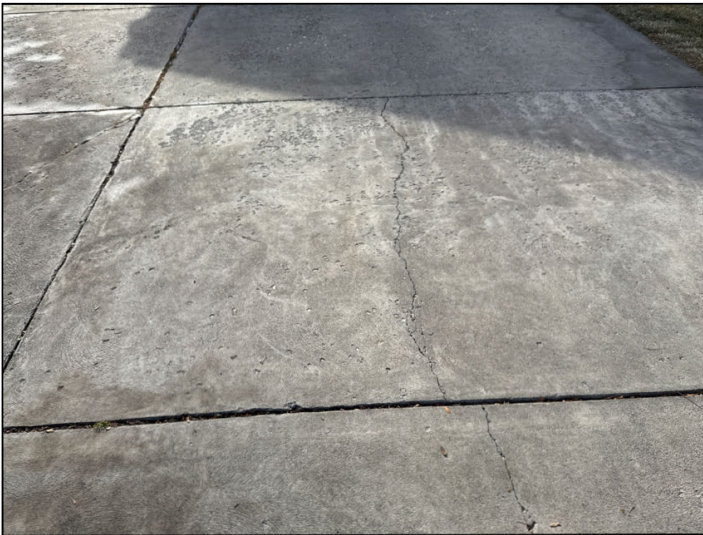
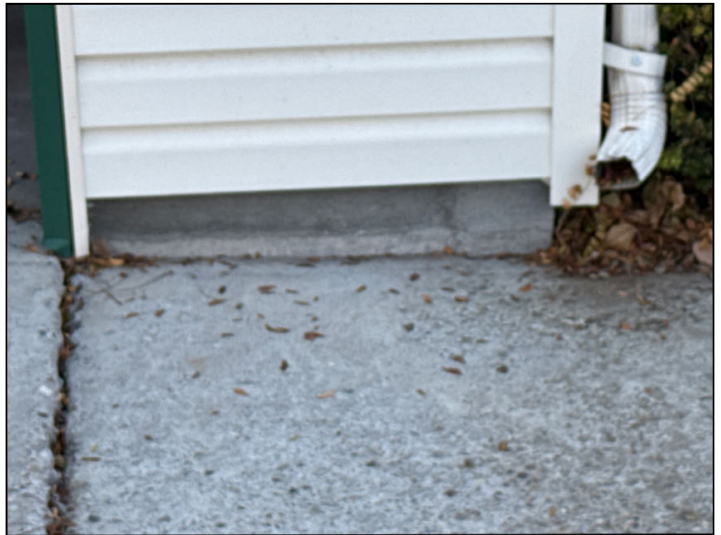
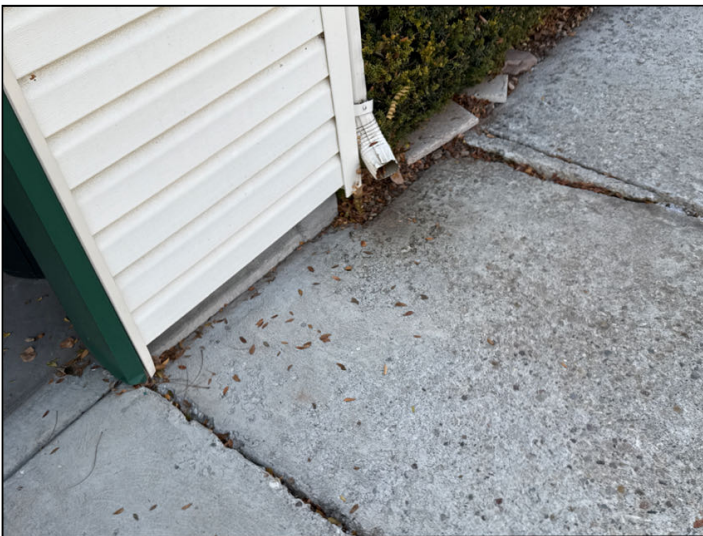
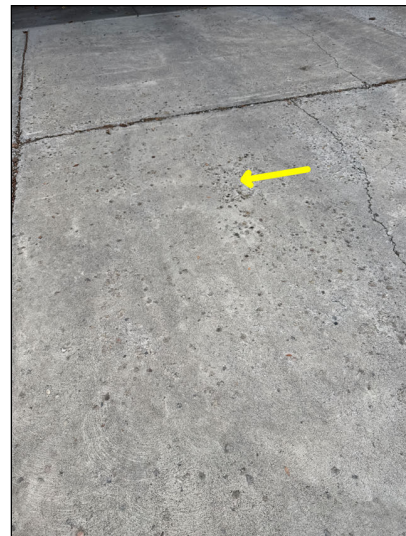
1. Driveway and Walkway Condition

- Monitor: Surface deterioration observed at the concrete surface.
- Improperly sloped towards foundation.
- Sunken areas were observed with cracks and breaks.
- Concrete spalling noted at driveway. This loosening of the top, smooth layer of the cement is a common occurrence, possibly due to an improper curing process, age, or use of snow-melting materials.

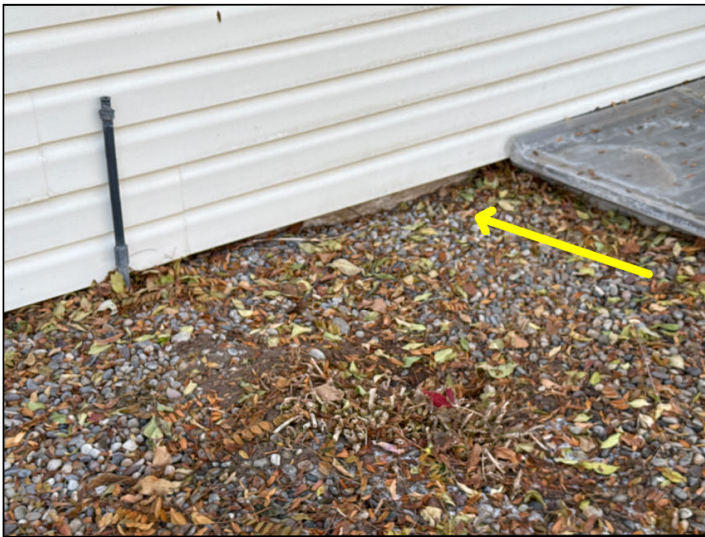
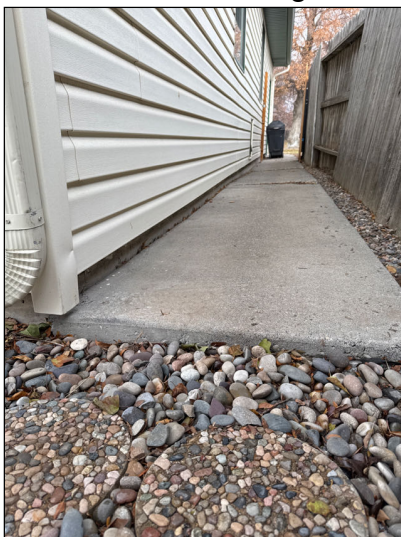
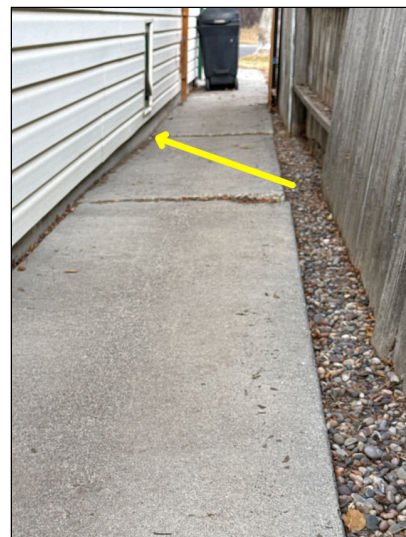
2. Grading

There are some low spots along the foundation. Recommend adding additional backfill to create the proper slope away from the house to allow for effective drainage.

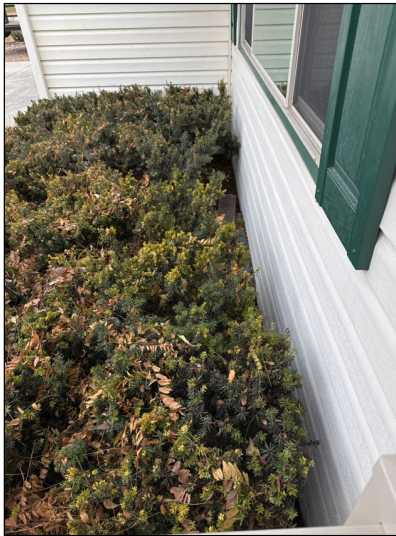
3. Vegetation Observations

- Prune or remove any plants that are in contact or proximity to home to eliminate pathways of wood destroying insects.

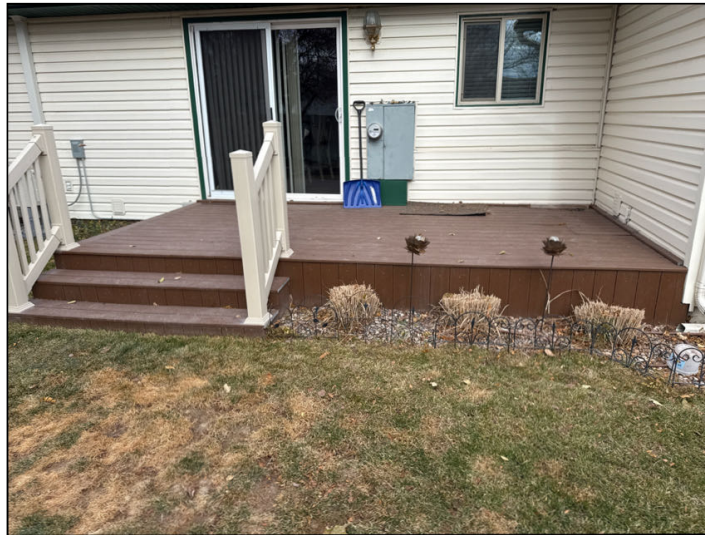
5. Patio and Porch Deck

- Appears in satisfactory and functional condition with normal wear for its age.
- MAINTENANCE: Even decks of composite lumber need periodic maintenance to keep them free of algae and mold that can make the surface very slick. Recommend cleaning composite decks annually by scrubbing with a solution of: 1/3 cup laundry soap; 2/3 cup Tri-Sodium-Phosphate (TSP); one quart bleach; and 3 quarts of water. Rinse with a hose--Do Not Use a Pressure-Washer on composite lumber.

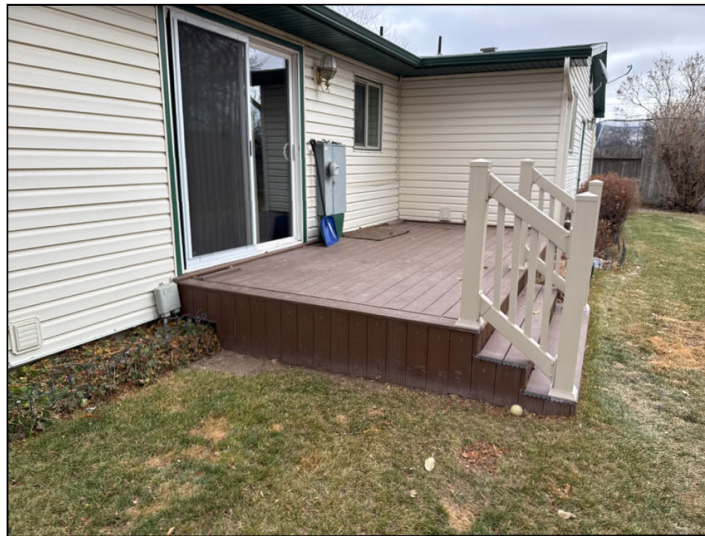
6. Stairs & Handrail

- ✓ Although railings are not required with drop-offs less than 30" above grade - consider your own personal needs and those of your family and guests. By today's standards, balusters (spindles) at decks and steps should be spaced no more than 4" apart for the safety of small children,
